US Army Corps
of Engineers®

Field Experience with Lock Culvert Valves

by **Richard L. Stockstill, E. Allen Hammack, Thomas E. Hood, and Jane M. Vaughan**

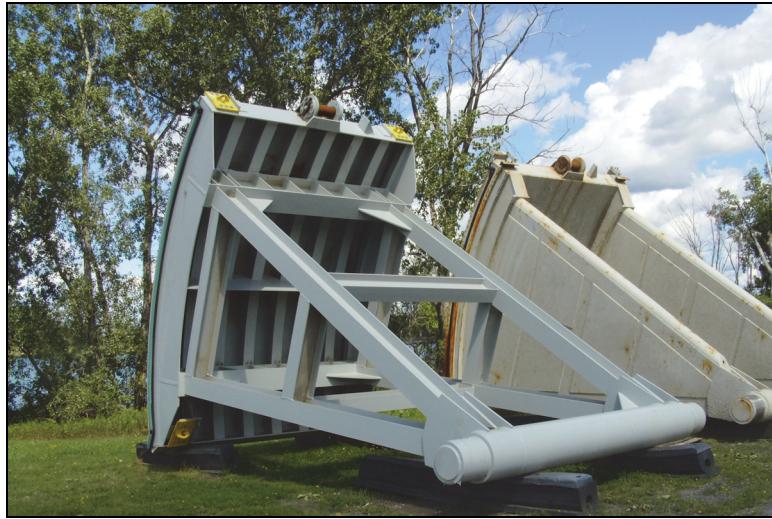
Eisenhower and Snell Locks. The valves on the Eisenhower and Snell Locks, two locks operated and maintained by the SLSDC, are being replaced. The existing valves are of double-skin construction. This design has lack of access to interior structural members. They are being replaced with new valves of a vertical-frame design to improve the ability for inspection and maintenance of structural members. A photograph of two of the SLSDC valves is provided in Figure 1 in which a vertical-frame valve is in front of a double-skin-plate valve. The double-skin construction wraps structural members such that the valve is *streamlined* because fewer objects are exposed to the flow. However, the semi-circular top and bottom of the valve arms are subject to flow-control oscillations, which in turn tend to vibrate the entire valve. Vibration of the double-skin-plate valves led the SLDC to add lateral dampers (dynamic vibration absorbers). Dampers, attached to the valves, ride against the valve's wall seals as shown in Figure 2. The dampers remedied the vibration problems.

Figure 1. Valves on the Eisenhower and Snell Locks: new vertically framed design in foreground, existing double-skin-plate design in background.

Two, new vertical-frame valves were furnished to the SLSDC in January 2011, and one was installed in the south filling-valve location at Snell Lock. An option for the SLSDC to order six more valves to complete the replacement was delayed because experience with the new vertical-frame valve currently in service revealed certain operational difficulties. Operation of the new valve exerted more load on the operating machinery than the double-skin-plate valve that it replaced, even though the new valve was significantly lighter. A hydraulic model study is currently underway to customize a vertical-frame valve design that meets SLSDC's requirements for hoist loads.

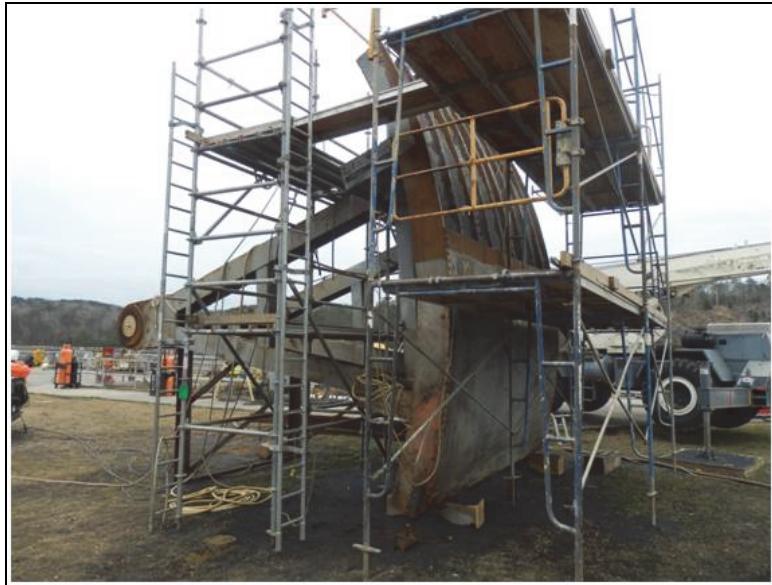
Bankhead Lock. The Bankhead Lock valves have performed well, and their design is recommended by SAM operations personnel. Regularly scheduled maintenance is currently underway wherein each valve is removed, repaired, and reinstalled. Maintenance crews noticed damage to the downstream side of a valve. When the valve was removed from the culvert, it was found that the skin plate damage was much more extensive than originally thought. The top third of the valve skin plate was removed (Figure 3) and replaced. Evidence of cavitation damage, more common downstream of lock valves, was noticed on the skin-plate steel, which had sharp-edged pits. The location of damage on the Bankhead Lock valve suggests that at certain valve openings, most likely small openings, high-velocity flow passes between the downstream side of the skin plate and the soffit seal.

Figure 3. Replacing upper skin plate on Bankhead Lock valve.

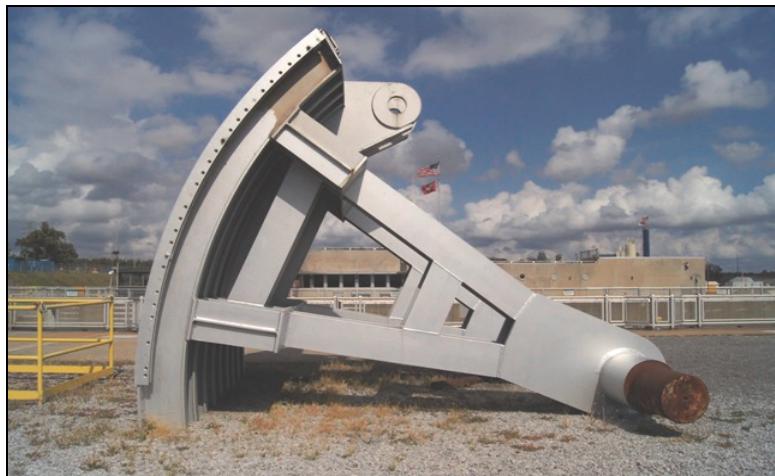
Kentucky Lock. New replacement valves were constructed for the Kentucky Lock circa 2004 (Figure 5). However, after the problems that had occurred with the replacement valves on Watts Bar Lock, USACE, Nashville District (LRN) believed the risk of having similar problems on Kentucky Lock was too great. The valves sat on a lock wall until a better understanding of why some designs have problems with uplift and vibrations could be found.

Figure 5. Kentucky Lock replacement valves.

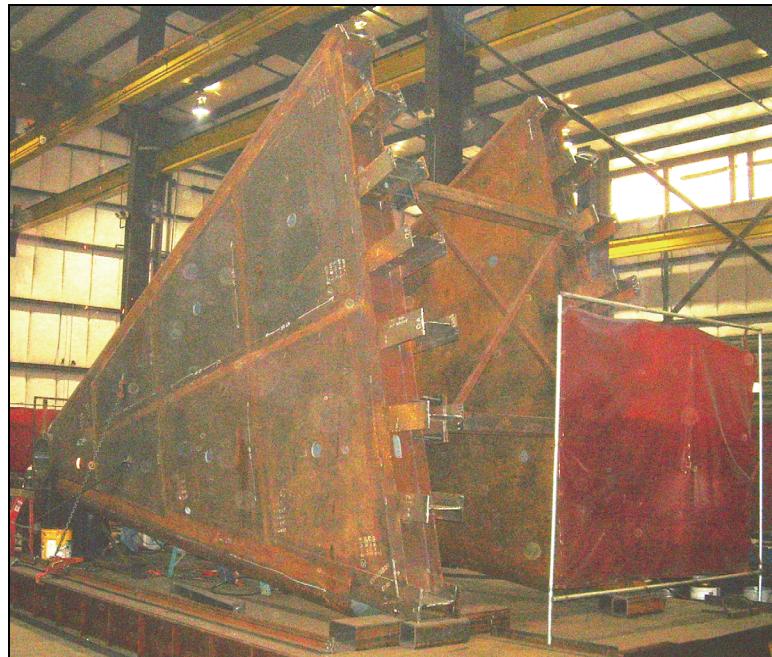
John Day Lock. The double-skin-plate valves used on John Day and the Dalles Locks have had cracks form in the steel wrapper plate of the valve members, and their structural performance has been unreliable over the years. A field inspection report reiterated that operation and maintenance of the valves have been difficult since completion of construction (North 2006).

Figure 6. New John Day Lock culvert valve during fabrication.

The USACE, Portland District (NWP) is replacing the valves. A photograph of a new valve taken during fabrication is provided in Figure 6, and one of a completed valve is shown in Figure 7.

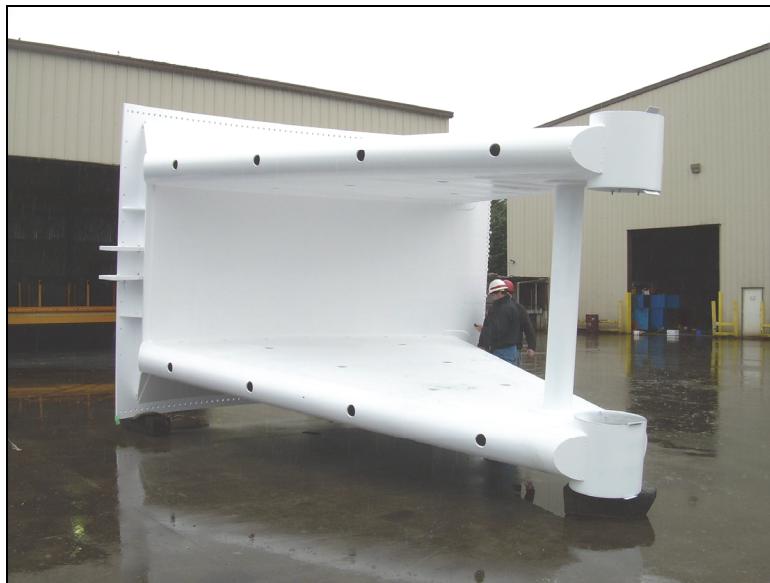
Figure 7. Newly fabricated John Day Lock culvert valve, turned on its side (top is on left).
